# Hollow Cathode Assembly Development for the HERMeS Hall Thruster

Timothy R. Sarver-Verhey (presenter) and Hani Kamhawi  
*NASA Glenn Research Center, Cleveland, OH, 44135*

**Presented at Propulsion & Energy 2019**  
**52<sup>nd</sup> AIAA/SAE/ASEE Joint Propulsion Conference**  
**Salt Palace Convention Center, Salt Lake City, UT**  
**25-27 July, 2016**

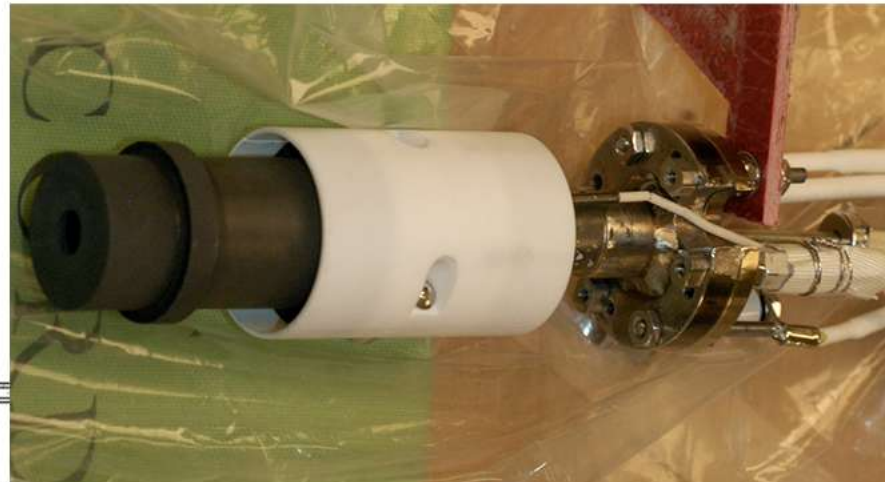
- Cathode Assembly Breakdown:

- Development cathode allowed rapid changes for characterization testing while being compatible with HERMeS TDU thrusters

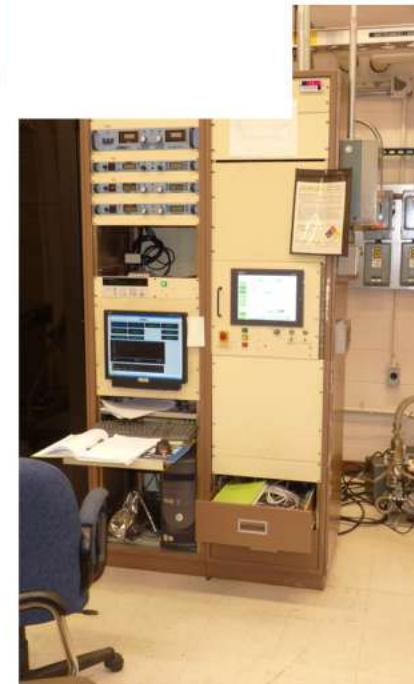
- Data Acquisition System

- Data logger connected to software on computer for data monitoring and display
- Interlocks enabled in software that disables power supply operation in event of limit trip

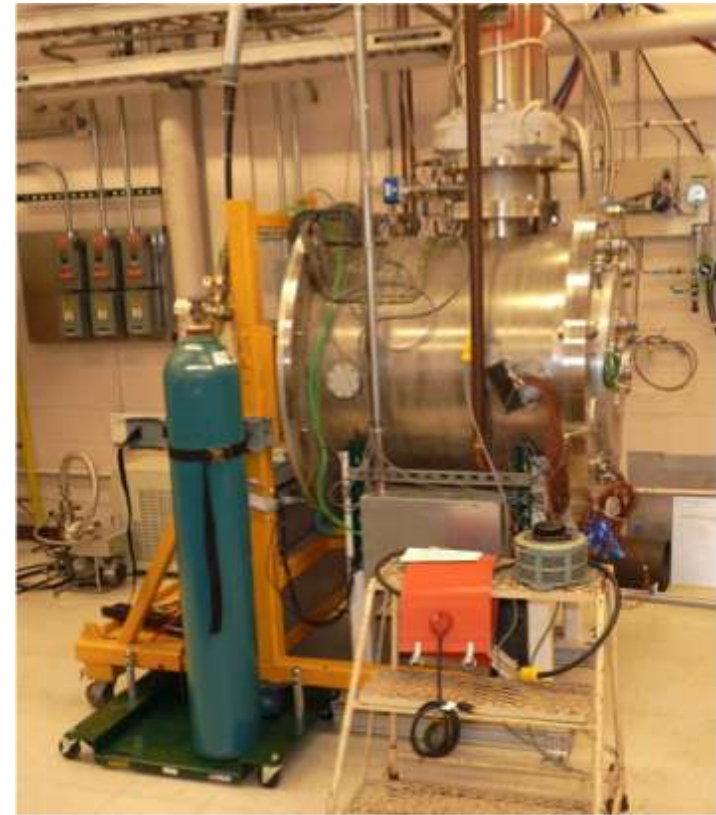
- VF-56 Test Facility
  - 1.0 m dia X 1.0 m L
  - Cryo-pumped –  $2 \times 10^{-6}$  Torr base,  $10^{-4}$  Torr at run condition
